Averting Degradation in the Abbay/GERD Basin: current trends, potential interventions and investment needs

Essayas Ayana, Semu Moges and Liya WeldeGebriel

Reverting Degradation Trend: Lessons learned from soil and water conservation (SWC) projects in Lake Tana basin

Tana Beles Integrated Water Resource Development Project (TBIWRDP)

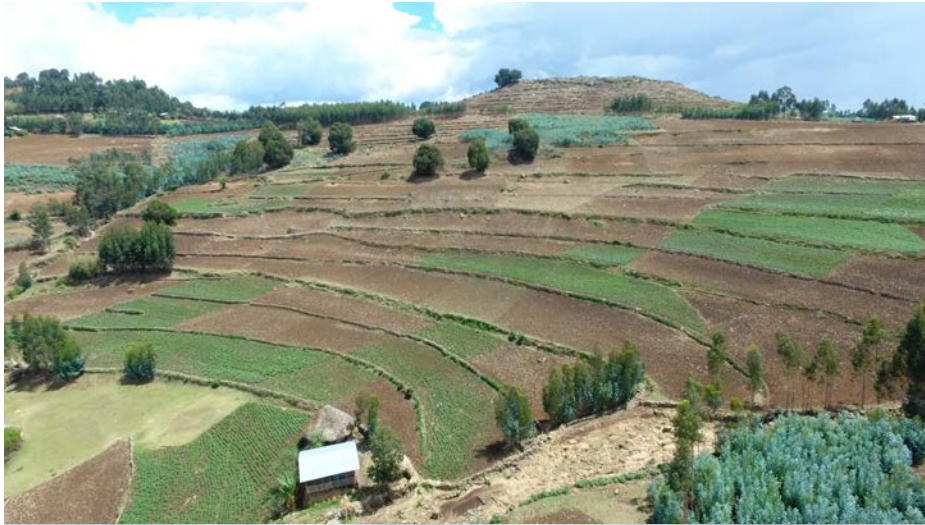
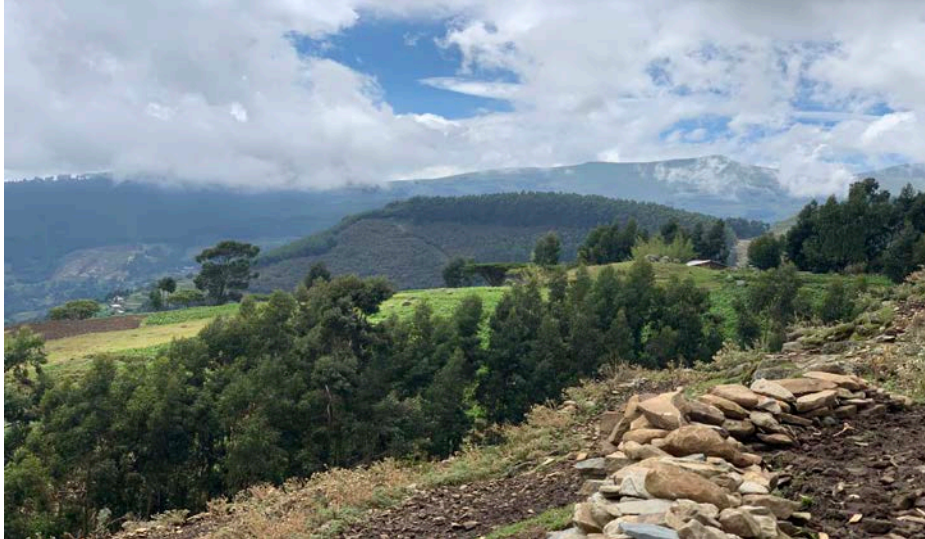
SWC practices implemented in TBIWRDP

Terraced hillslopes with agroforestry

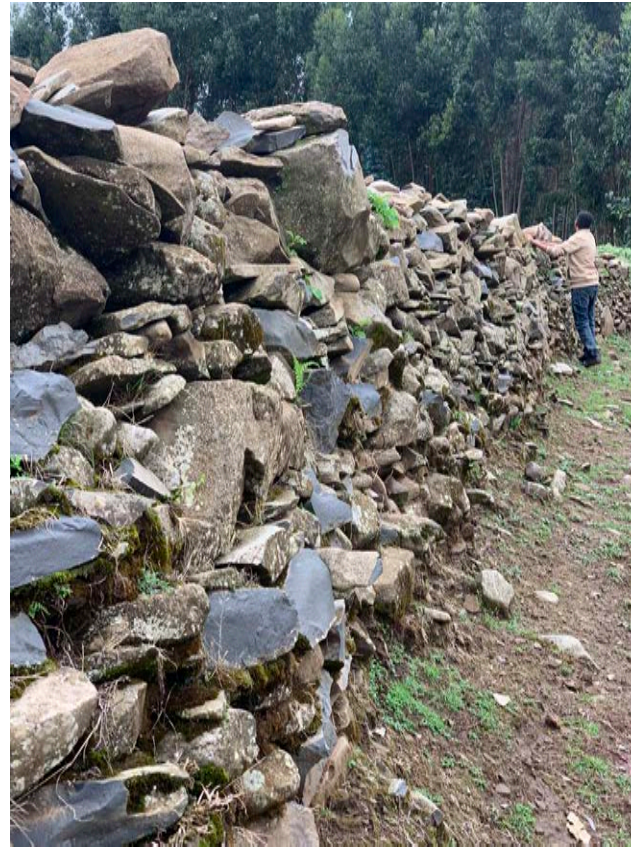
Detail of stones terrace

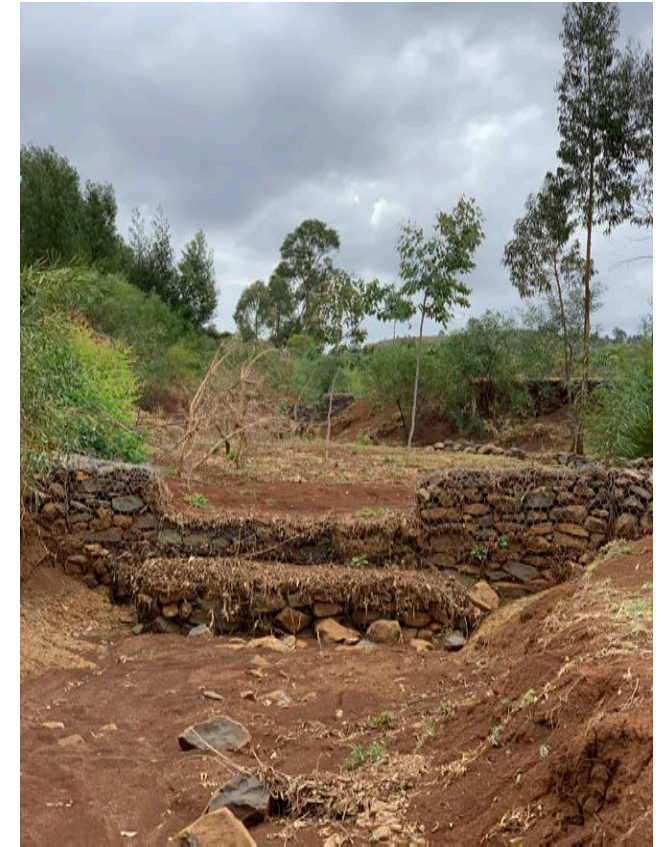
Gabion check-dam

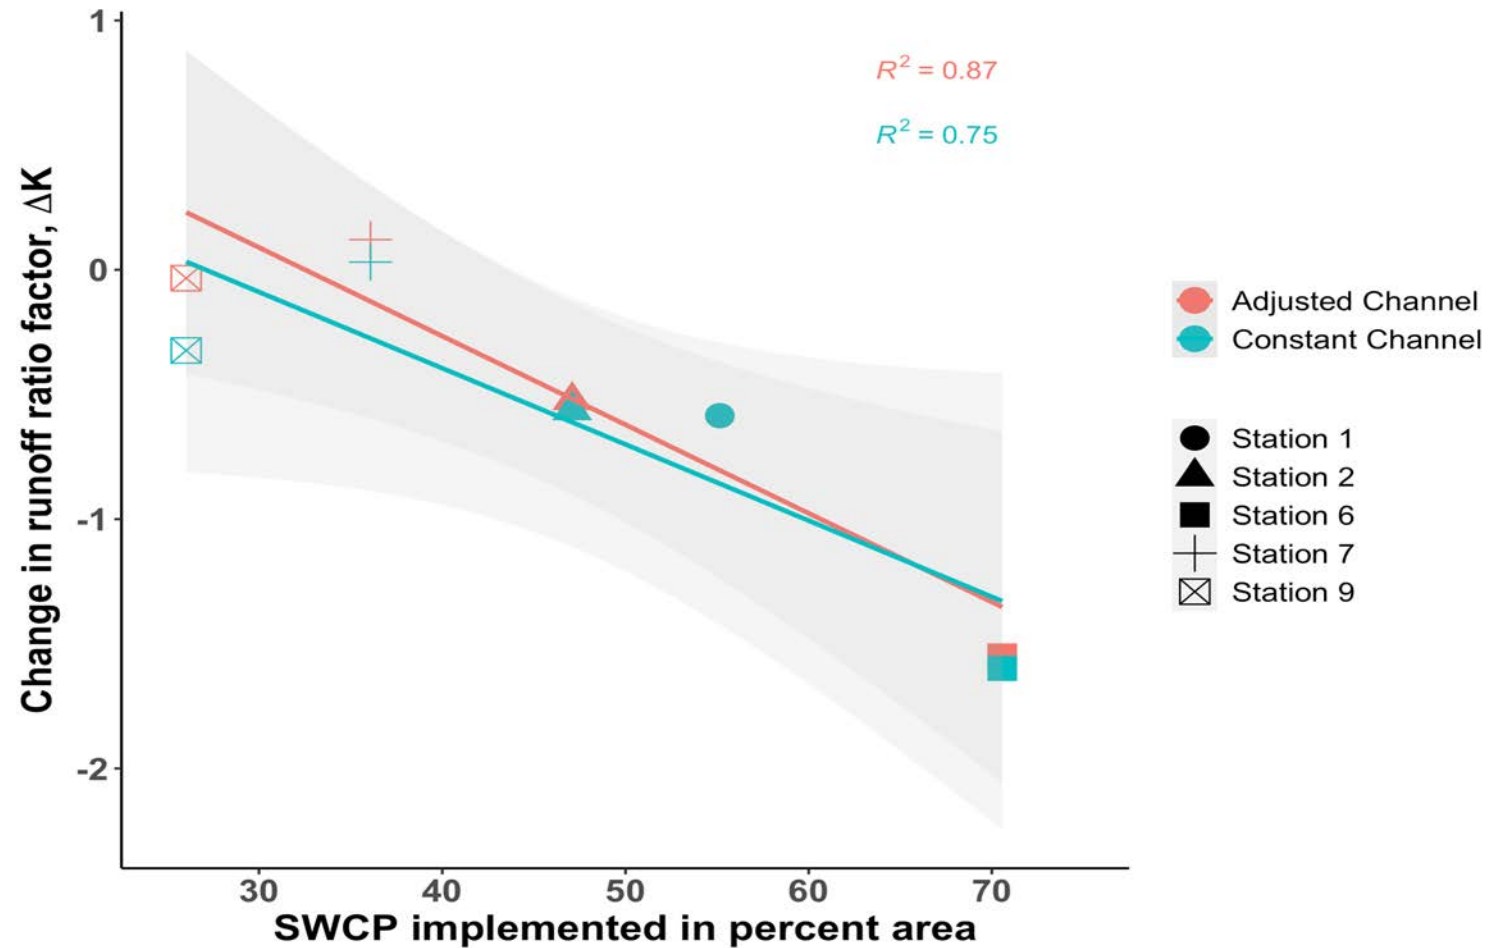
Impact of SWC practices on runoff ratio

Figure 1. Density of SWC practices vs change in runoff ratio factor between 2010 and 2012 in Kiremt (wet) season

- ❖ Stage height, sediment concentration and vegetation indices (NDVI) can be used to detect impact of SWC practices
- ❖ Terraces, check dams and agroforestry has shown positive short-term impact by reducing runoff and soil erosion in small scale watersheds
- ❖ “No free grazing” policy has increased vegetation cover in the long term

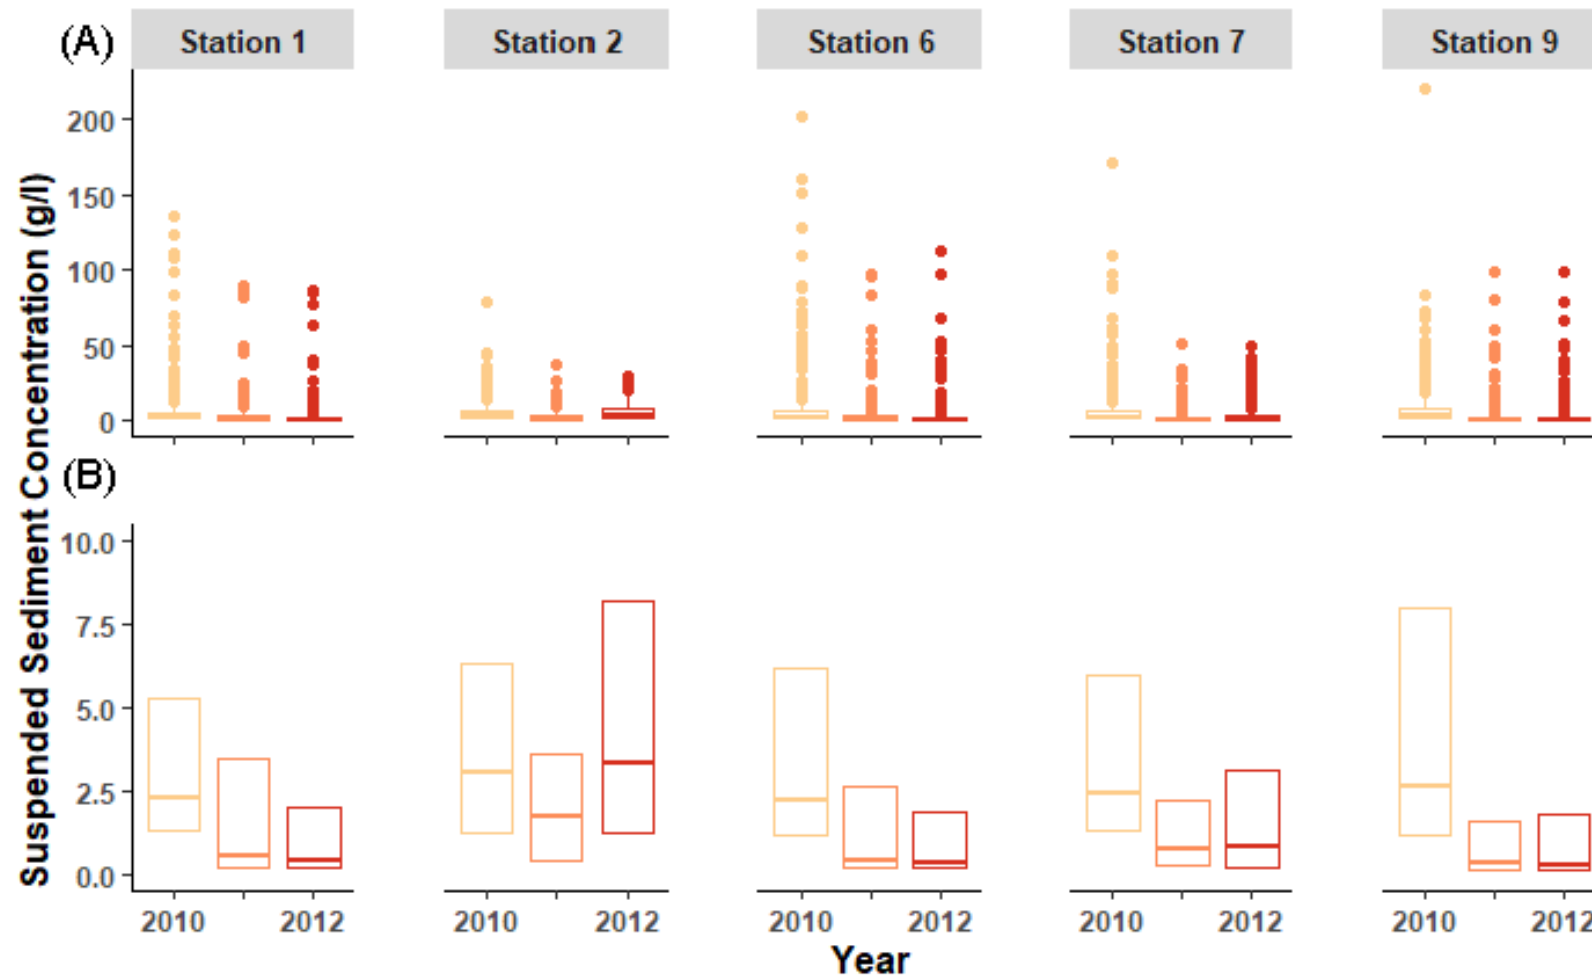
Impact of SWC practices on sediment concentration

Figure 2. Suspended sediment concentration (g/l) for Kiremt season from 2010 to 2012. (A) including outliers, (B) without outliers
